ECHO LAKE DAM

NJ 00133

PHASE 1 INSPECTION REPORT
NATIONAL DAM SAFETY PROGRAM

JULY 1981

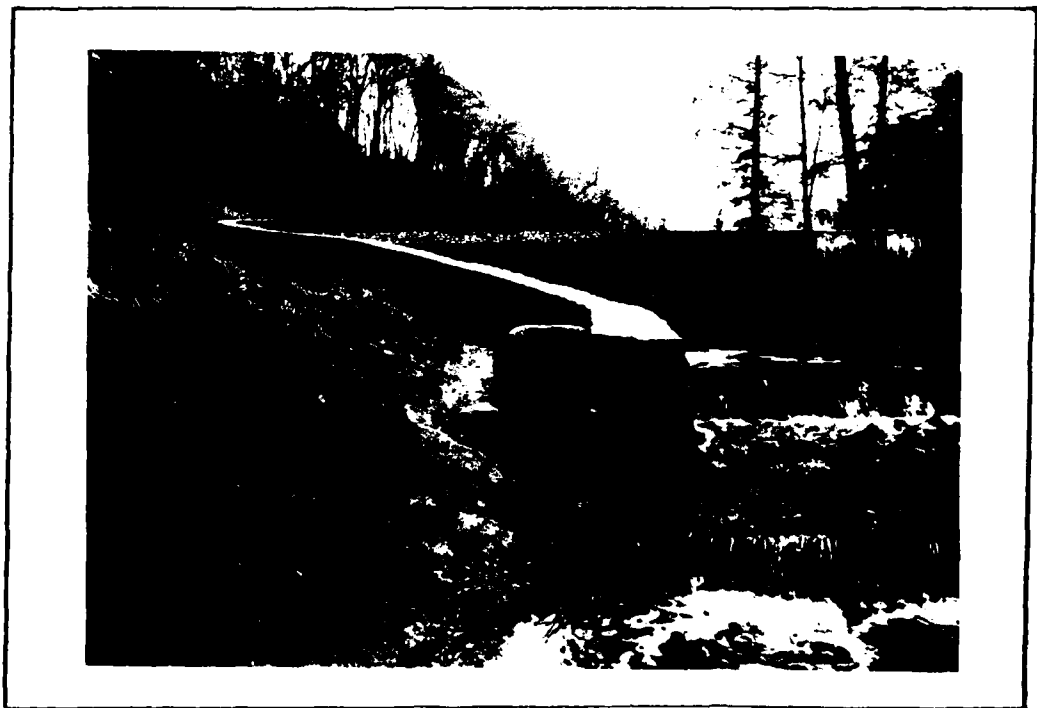
6. CHANNEL AND BANK CONDITIONS ON THE RIGHT SIDE AT THE DOWNSTREAM END OF THE STEP CHANNEL SPILLWAY. (4/24/81)

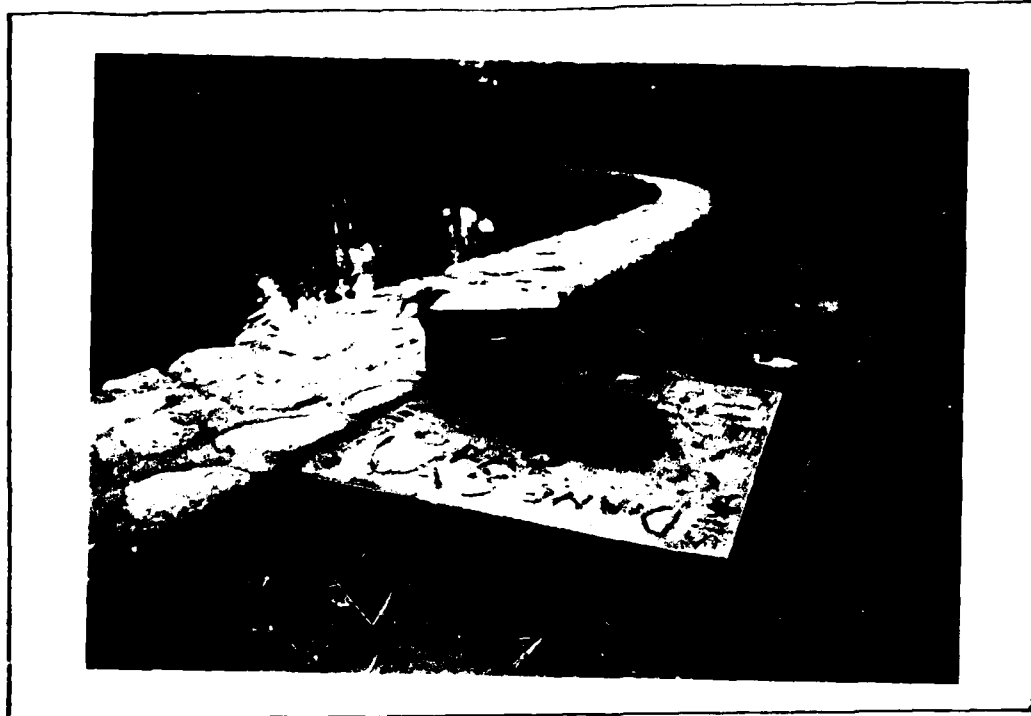
Most of the reservoir drain structure is not visible; however, no discharge was observed at the outlet. The Owner was unable to open the drain valve at the time of the inspection because the access well was filled with debris. According to the Owner's representative, the valve is not exercised regularly and has not been activated since completion of the reconstruction in 1975.

c. Visual Observations. At the time of the inspection, some debris was accumulated at the spillway crest. The vertical access well to the reservoir control valve was obstructed with debris. The operational condition of the valve could not be assessed.

a. Evaluation. Based on the visual inspection, Echo Lake Dam is judged to be in good condition. The access well to the reservoir drain is blocked with debris. It is not known if the valve is operational.

7. ACCESS TO THE RESERVOIR DRAIN PIPE VALVE ON THE RIGHT SIDE OF THE DAM. (4/24/81)

3. The access well to the reservoir drain should be cleared of debris and the surface opening secured. The operational condition of the valve should be assessed.

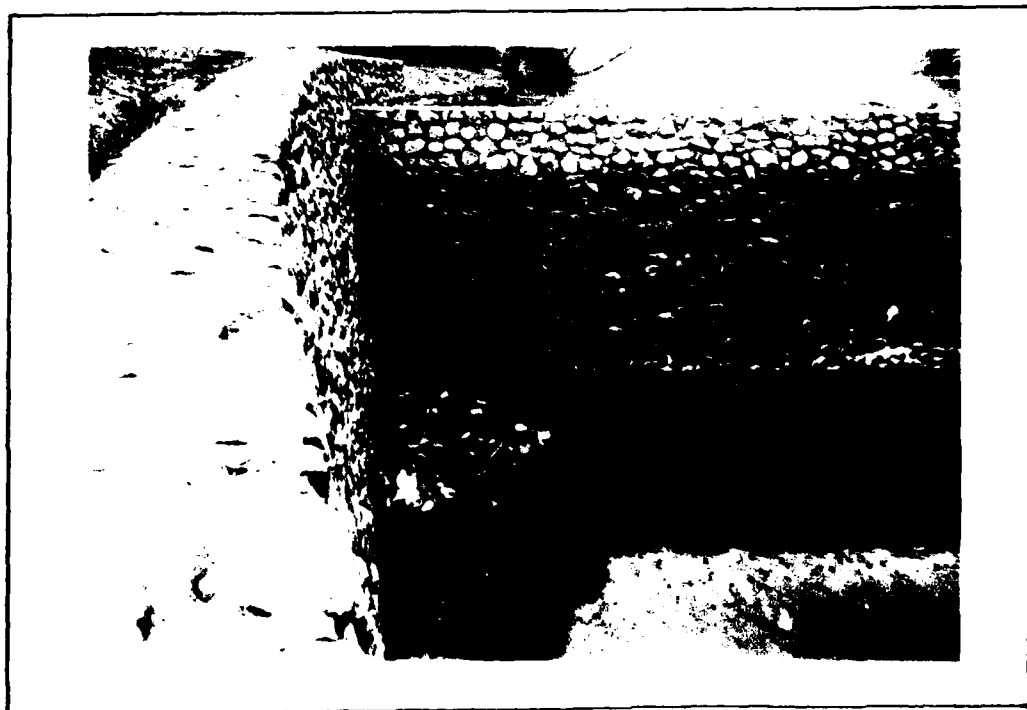
8. OUTLET OF THE RESERVOIR DRAIN PIPE ON THE RIGHT SIDE OF THE DAM. (4/24/81)

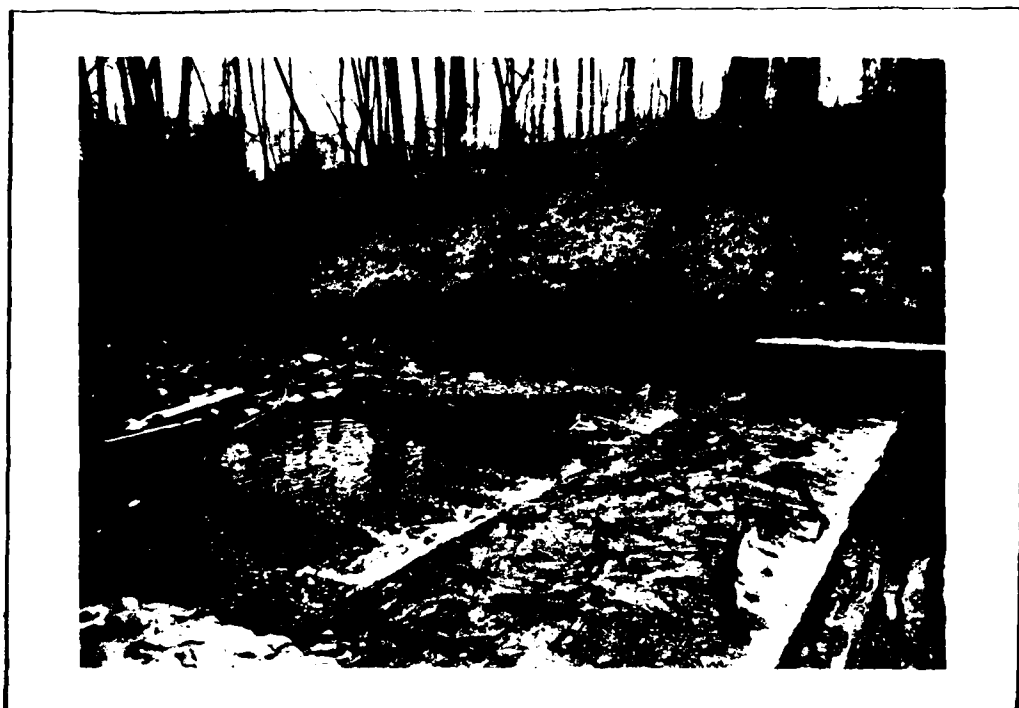
9. CHANNEL AND BANK CONDITIONS IMMEDIATELY DOWNSTREAM OF STEPPED CHANNEL. (4/24/81)

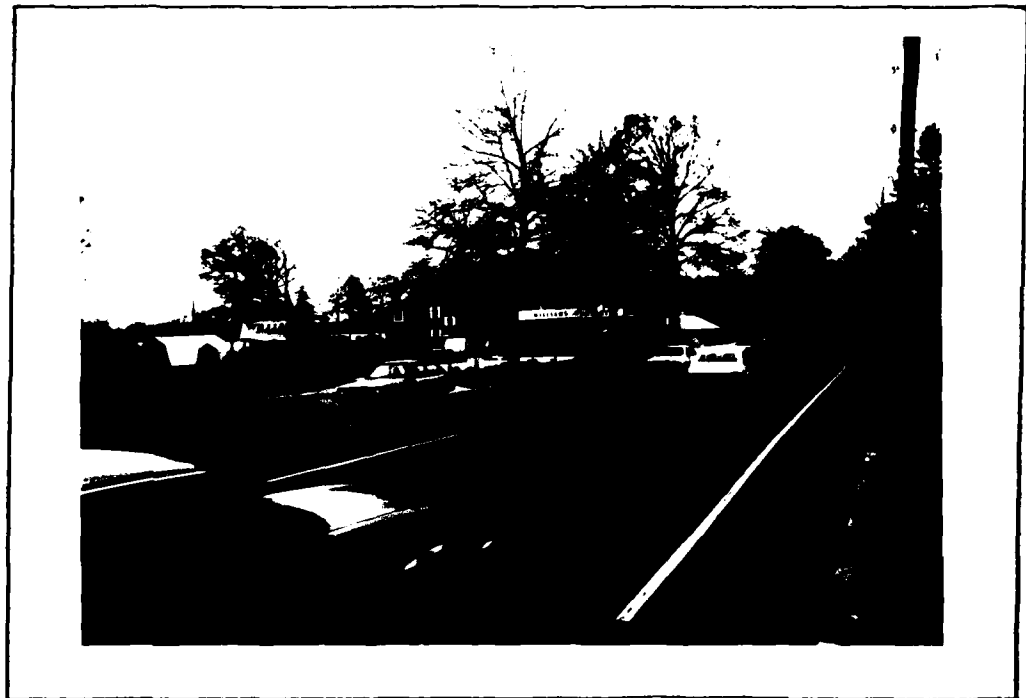
14. POTENTIAL DAMAGE AREA RIGHT OF THE CHANNEL ABOUT 0.25 MILES
DOWNSTREAM OF ECHO LAKE DAM. (4/24/81)

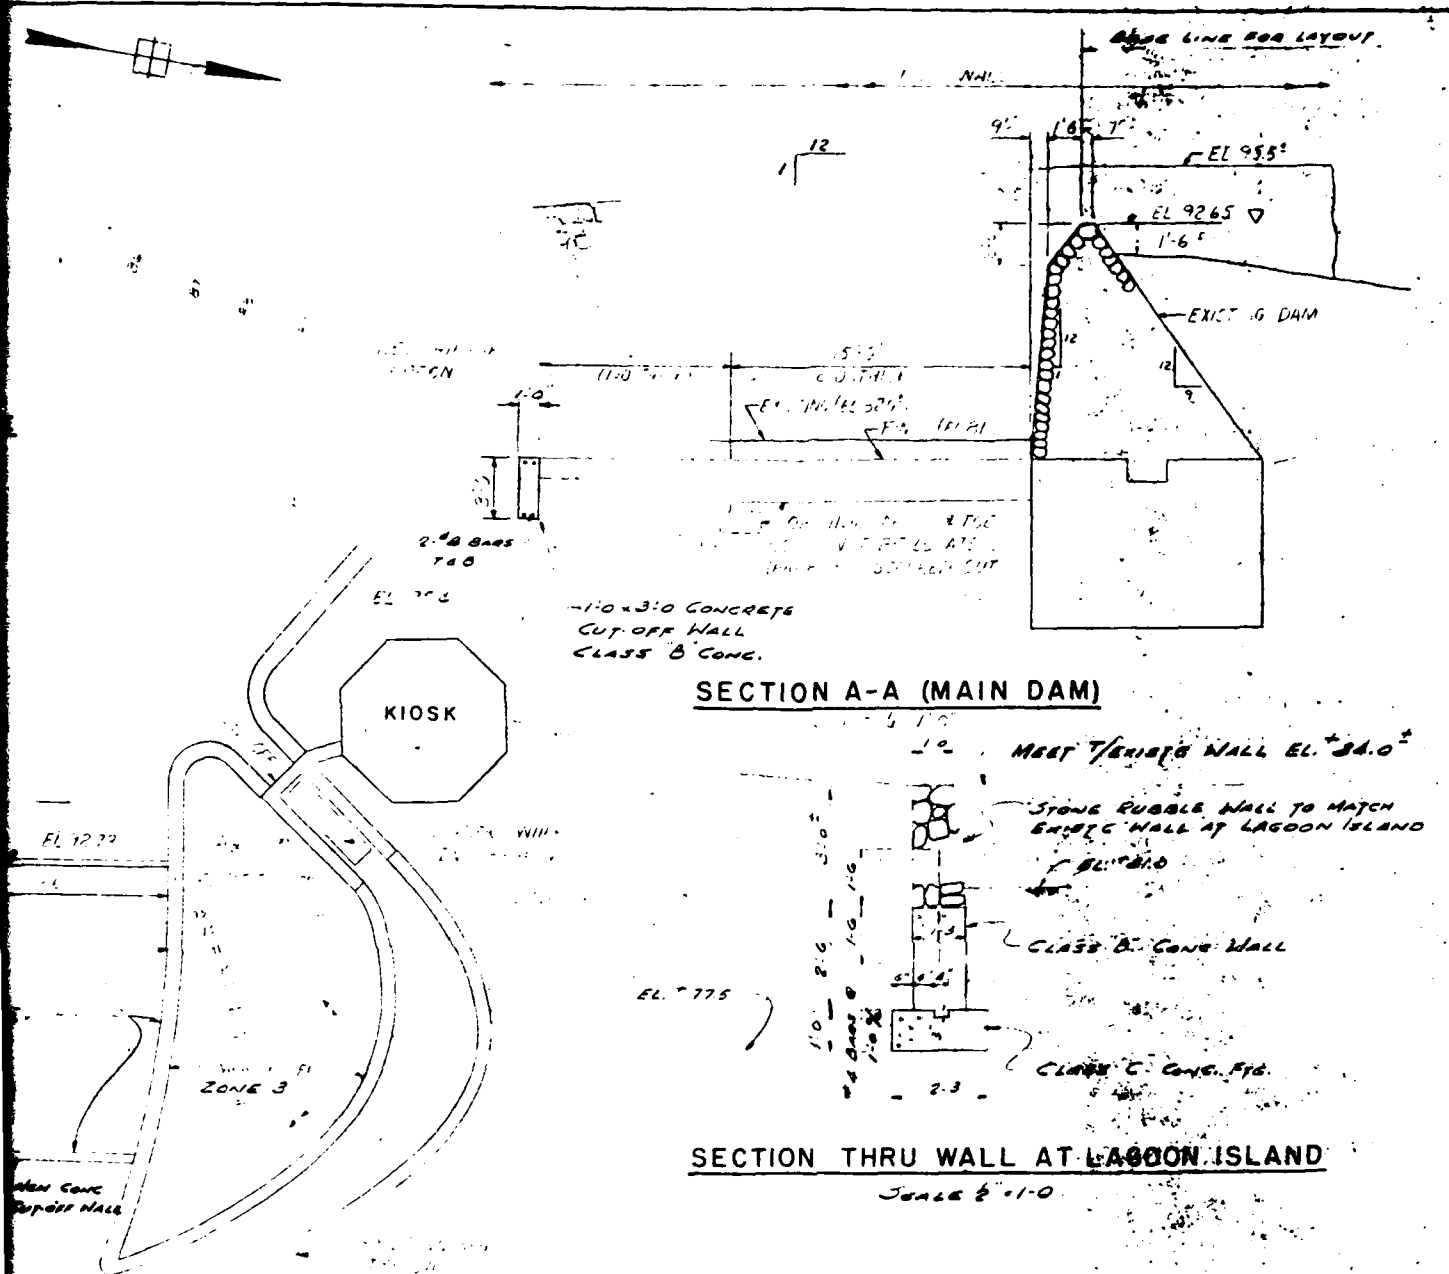
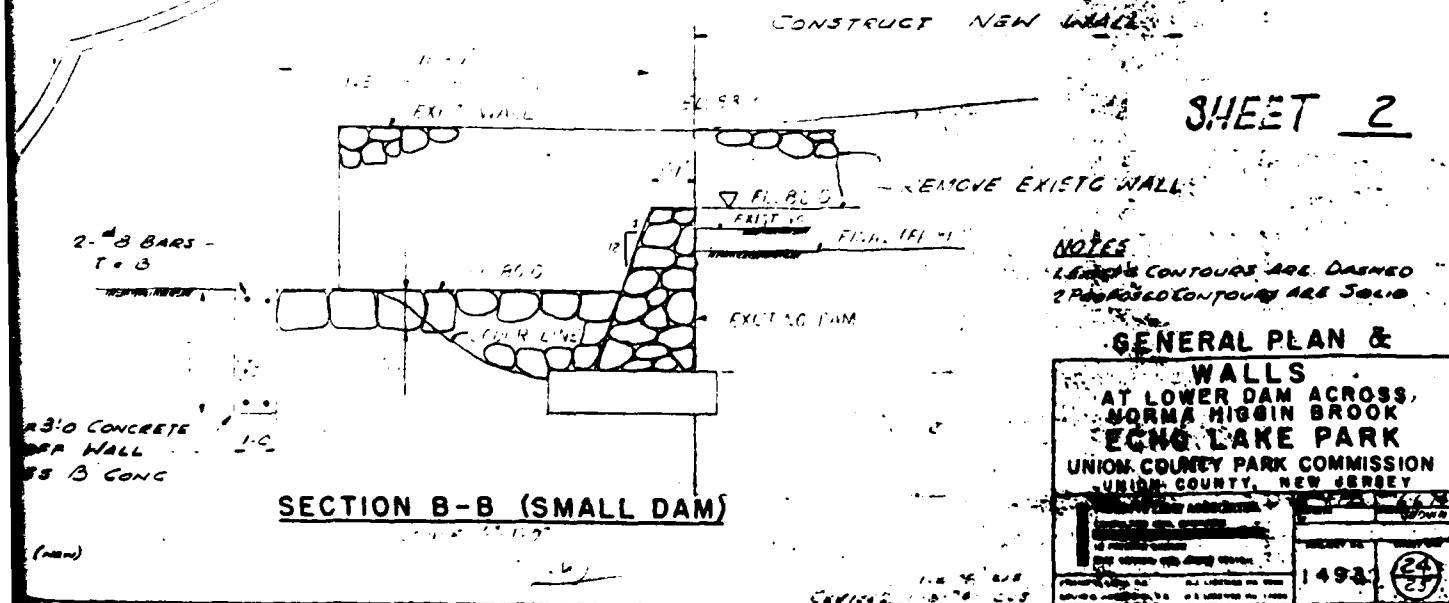
f. Structural Stability. Spillway sections represented by Section A-A on Sheet 2 of Appendix E and Section C-G on Sheet 3 of Appendix E were analyzed for structural stability with the water in the impoundment at the spillway crest Elevation 92.6 and no tailwater. Full uplift conditions, varying from the impoundment elevations at the upstream end to the base of the dam at the downstream end were assumed for the analyses. The resultant of forces is located outside the middle third of the base for both sections. The criteria outlined in the Recommended Guidelines for Safety Inspection of Dams states that the resultant should be located within the middle third of the base width. Refer to Appendix G for the structural stability calculations.

Seismic and structural stability analyses were performed for the spillway sections. Based on these analyses, the spillway sections of the dam meet the criteria for seismic stability but do not meet the requirements for structural stability according to the criteria outlined in the Recommended Guidelines for Safety Inspection of Dams.
